Flood Control Project Maintenance**2013 Structure Summary Report****Overall Unit and Item Ratings****Lake County Watershed Protection District****Clover Creek Diversion Structure**

Flood Control Project Maintenance**Unit Cover Sheet****2013 Structure Inspection Results****Lake County Watershed Protection District**

Structure
Clover Creek Diversion Structure

Structure Rating	M
Date of Inspection	08/06/2013
DWR Inspector	Pavel Kazi
Accompanied By	Bob Duffey DWR

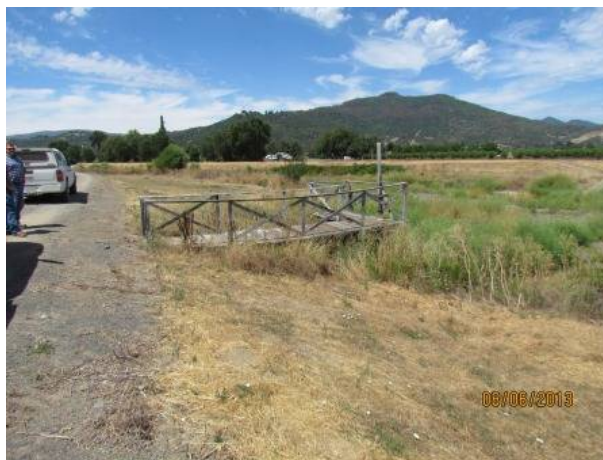
Levee Mile Report Line	1
Start Levee Mile	0.00
End Levee Mile	0.00
Location	
Category	Structures
Item	Photo Documentation

LMR No.	Levee Mile		Category	Item	Location *	Rating **	Action/Comment	GPS Latitude/Longitude		Issue No.
	Start	End						Start	End	
1	0.00	0.00	Structures	Photo Documentation		N	Inspector Comments: Clover Creek Diversion Structure has three culverts with two flap and slide gates to divert the water during high water season.	39.177050 ° -122.898750 °	39.177050 ° -122.898750 °	1 Y
2	0.00	0.00	Structures	Vegetation & Obstructions		M	Inspector Comments: The channel had vegetation and scattered obstructions.	39.177050 ° -122.898750 °	39.177050 ° -122.898750 °	2 Y
3	0.00	0.00	Structures	Shoaling / Sedimentation		A	Inspector Comments: No sediment was present during the inspection.	39.177050 ° -122.898750 °	39.177050 ° -122.898750 °	3
4	0.00	0.00	Structures	Erosion / Bank Caving		A	Inspector Comments: There was no visible active erosion or bank caving observed.	39.177050 ° -122.898750 °	39.177050 ° -122.898750 °	4

View of the diversion structure.

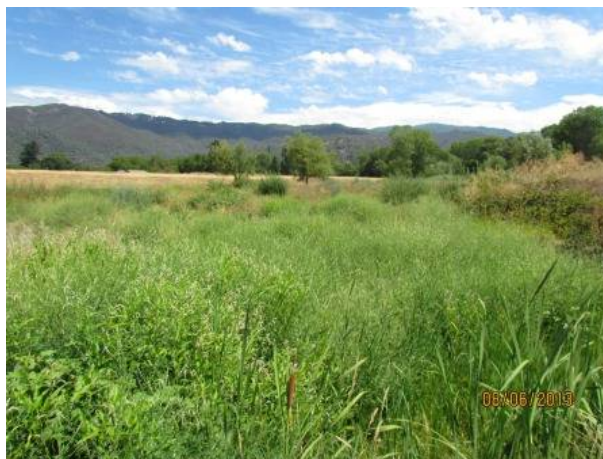
Levee Mile Report Line	2
Start Levee Mile	0.00
End Levee Mile	0.00
Location	
Category	Structures
Item	Vegetation & Obstructions

View of the vegetation at the inlet of the structure.

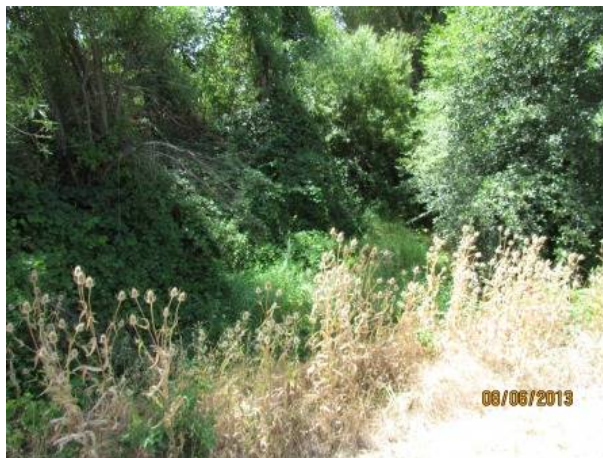
Levee Mile Report Line	2
Start Levee Mile	0.00
End Levee Mile	0.00
Location	
Category	Structures
Item	Vegetation & Obstructions

View of the vegetation at the outlet of the structure.

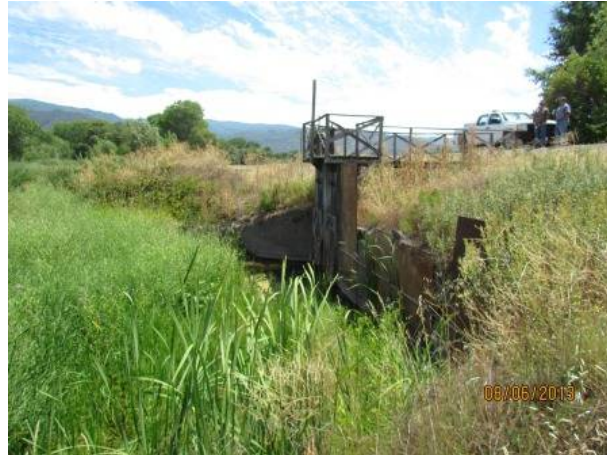
Levee Mile Report Line	7
Start Levee Mile	0.00
End Levee Mile	0.00
Location	
Category	Structures
Item	Culverts: Inlets / Outlets
View of the culvert inlet.	
pkazi_t_20130820_328.JPG

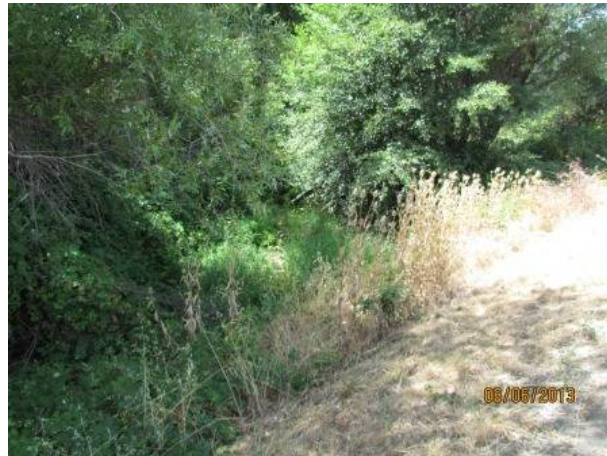
Levee Mile Report Line	7
Start Levee Mile	0.00
End Levee Mile	0.00
Location	
Category	Structures
Item	Culverts: Inlets / Outlets
View of the culvert outlet.	
pkazi_t_20130820_329.JPG

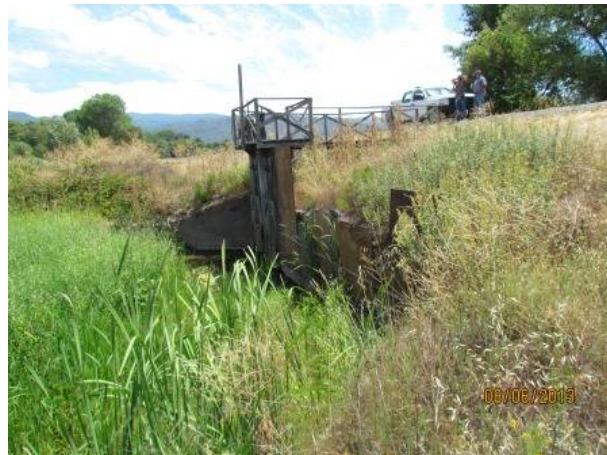
11	0.00	0.00	Structures	Flap Gates		A	Inspector Comments: Flap gates appeared to be in good condition.	39.177050 ° -122.898750 °	39.177050 ° -122.898750 °	11
12	0.00	0.00	Structures	Sluice/Slide Gates		A	Inspector Comments: The slide gates appeared to be in good working condition.	39.177050 ° -122.898750 °	39.177050 ° -122.898750 °	12 Y
13	0.00	0.00	Structures	Electric Gate Operators		N	Inspector Comments: This item does not apply to this inspection.	39.177050 ° -122.898750 °	39.177050 ° -122.898750 °	13
14	0.00	0.00	Structures	Manual Gate Operators		A	Inspector Comments: The manual gate operator appeared to be operational.	39.177050 ° -122.898750 °	39.177050 ° -122.898750 °	14 Y

Levee Mile Report Line	12
Start Levee Mile	0.00
End Levee Mile	0.00
Location	
Category	Structures
Item	Sluice/Slide Gates
View of the slide gate.	
pkazi_t_20130820_330.JPG

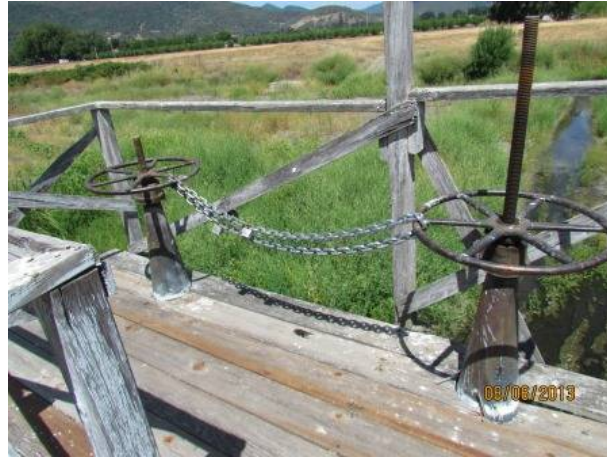
Levee Mile Report Line	14
Start Levee Mile	0.00
End Levee Mile	0.00
Location	
Category	Structures
Item	Manual Gate Operators

View of the manual gate operator.

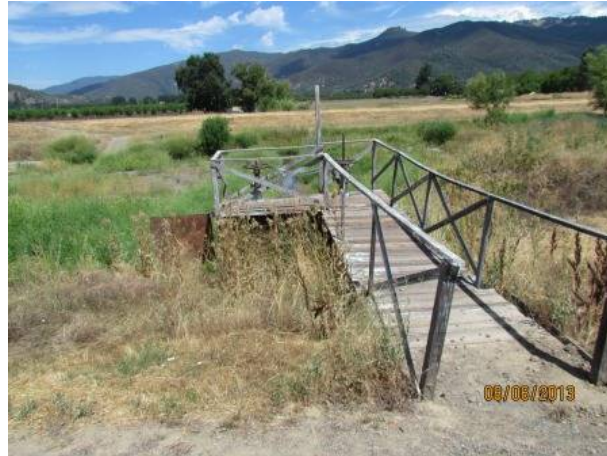
Levee Mile Report Line	23
Start Levee Mile	0.00
End Levee Mile	0.00
Location	
Category	Structures
Item	Safety

View of the wooden guard rail.
